**Flood Control Project Maintenance
Levee Inspections**

Maintenance Issue Types Only, Levee Inspection Report By Mile - Spring 2018

Butte County Department of Public Works

Waterway	Bank	Unit Miles	Inspection Start/End	Inspector
Unit No. 01 Mud Creek	Right	6.80	03/20/2018 03/20/2018	Bob Duffey

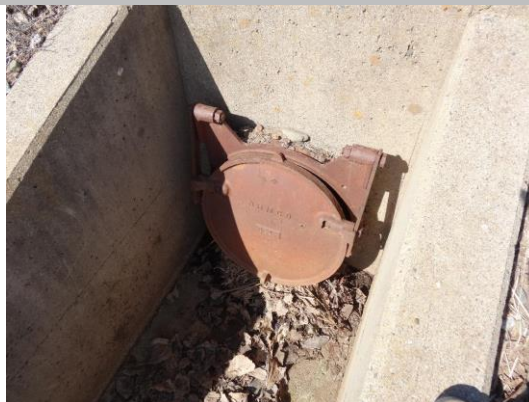
Photo 2 of 3 : UCIP_SP_2018_32044_58542.jpg

WS view: vegetation debris blocking outlet.

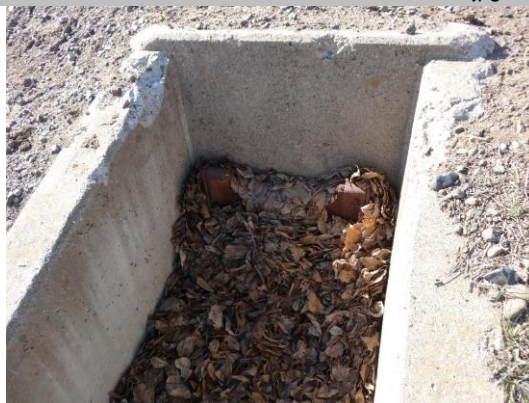
Photo 1 of 2 : UCIP_SP_2018_30295_55706.jpg

Comment Code						
Inspector Comment						
FS_ID:30295						
DS_ID:19217						
EP_NO: N/A						
Repair Type: Non-Urgent						
Crossing Status: Found						
UCIP Comments: It needs cleaning and clearing in inlet and outlet ends.						
FIELD_STRUCT_DESC: 24-inch corrugated metal gravity drainage pipe						
through the levee, 9 feet below the crown. Flap gate on the waterside						
(WS) end. Concrete U-shaped headwall on each end. Grouted riprap						
apron on the landside (LS) end. Grouted riprap spillway on the WS end.						
[Additional Reference(s): DWR Levee Log, 1992. USACE Sacramento						
O&M Manual 504, May 1965, (HLM 3.27)].						
FS Date: 2/20/2014

WS view: U type concrete headwall, flapgate on levee slope. Vegetation debris blocking the outlet.

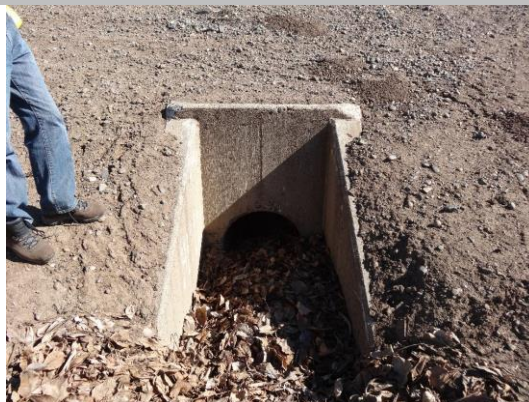
Photo 2 of 2 : UCIP_SP_2018_30295_55705.jpg

LS view: U type concrete headwall and CMP on levee slope. Vegetation debris blocking the inlet.

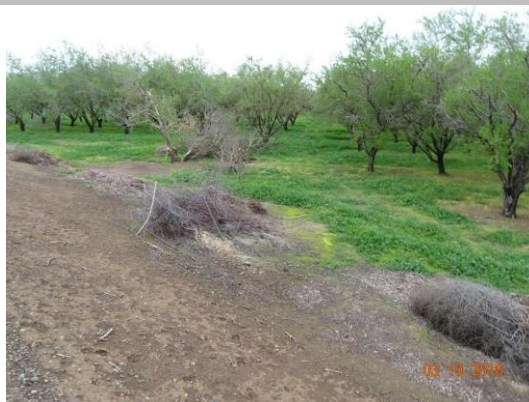
Photo 1 of 1 : SP_2018_NA0003_64_32_20180402_00067.jpg

View of the prunings along the landside toe.

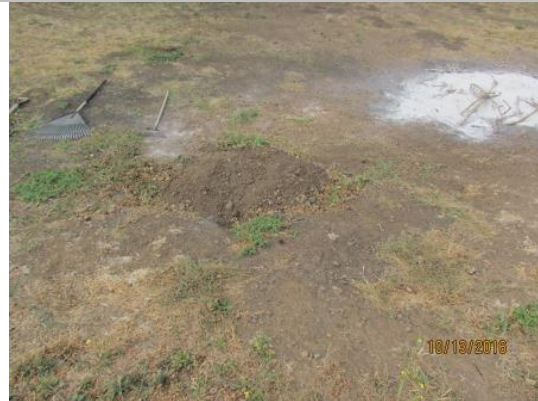
Photo 1 of 1 : SP_2018_NA0003_64_51_20180305_00030.jpg

View of the rodent holes along the landside slope.

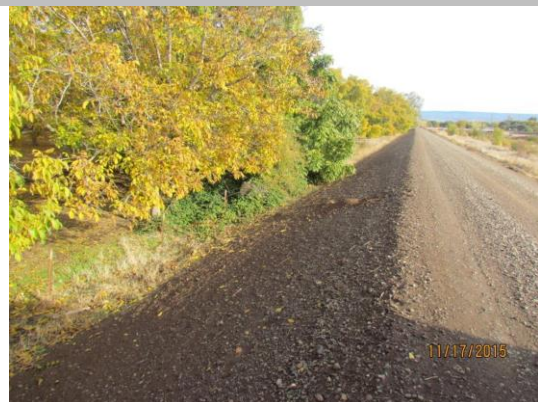
Photo 1 of 1 : SP_2018_NA0003_64_33_20180305_00015.jpg

View of the rodent holes along the landside slope.

LM Start	4.27	Rating **	M	Issue No.	33
LM End	4.27	Issue Type +	Ma	Location *	LS
Category	Earthen Levee			GPS Latitude/Longitude	
				Start	End
Item	Animal Control			39.773398 °	39.773398 °
				-121.895765 °	-121.895765 °
DWR ID	DWR_NA0003_01_f_2015_33				
Comment Code					
A1 : Exterminate rodents and backfill and compact or grout burrows.					
Inspector Comment					
Repair the rodent holes along the landside slope.

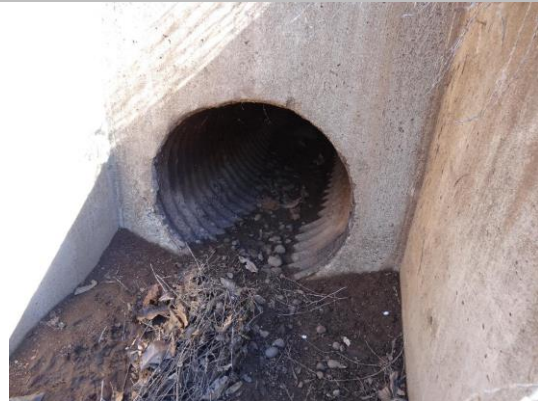
Photo 2 of 2 : UCIP_SP_2018_30312_55744.jpg

LS view: U type concrete headwall and CMP on levee slope. Needs cleaning and clearing of debris.

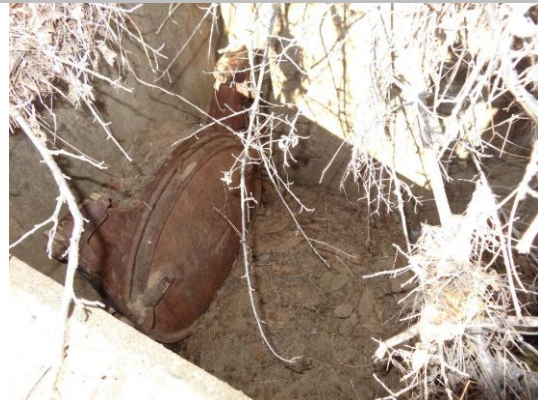
Photo 1 of 2 : UCIP_SP_2018_30388_55891.jpg

WS view: U type concrete headwall, pipe, and flapgate on levee slope. Vegetation/soil debris blocking outlet.

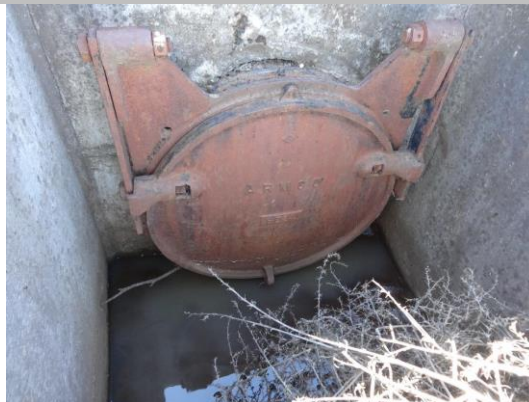
Photo 2 of 3 : UCIP_SP_2018_31667_57967.jpg

WS view: U type concrete headwall, pipe, and flapgate on levee slope. Vegetation debris on outlet box.

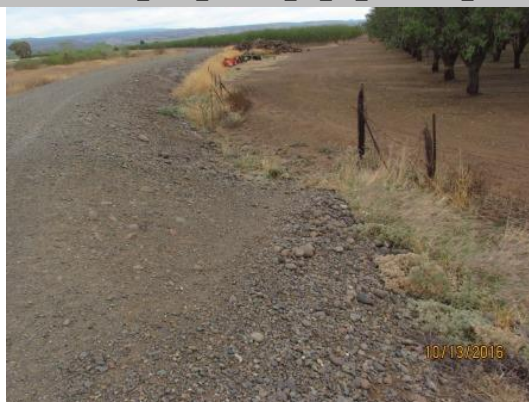
Photo 1 of 1 : SP_2018_NA0003_65_29_20180305_00008.jpg

View of the slope instability caused by vehicles along the landside slope.

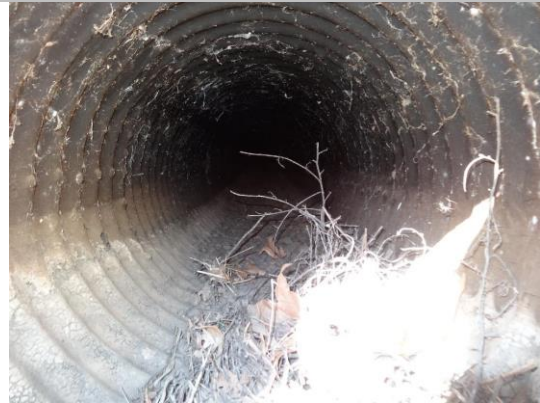
Photo 3 of 3 : UCIP_SP_2018_30403_55920.jpg

LS view: inside view of CMP on levee slope. Needs cleaning and clearing.

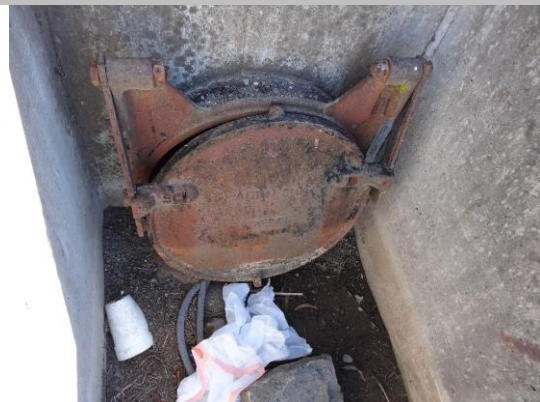
Photo 1 of 2 : UCIP_SP_2018_30743_56641.jpg

WS view: U type concrete headwall, pipe, and flapgate on levee slope.
Debris in outlet box.

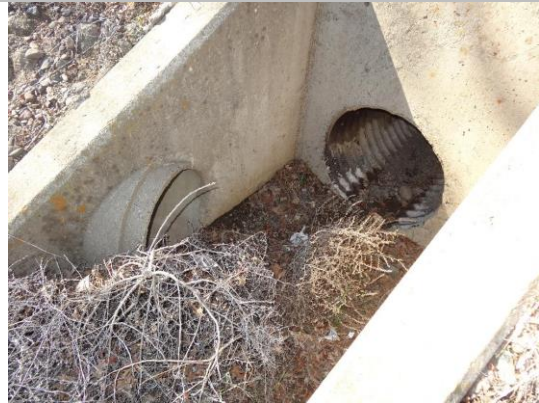
Photo 2 of 2 : UCIP_SP_2018_30743_56640.jpg

LS view: U type concrete headwall and CMP on levee slope. Vegetation debris and soil in inlet area.

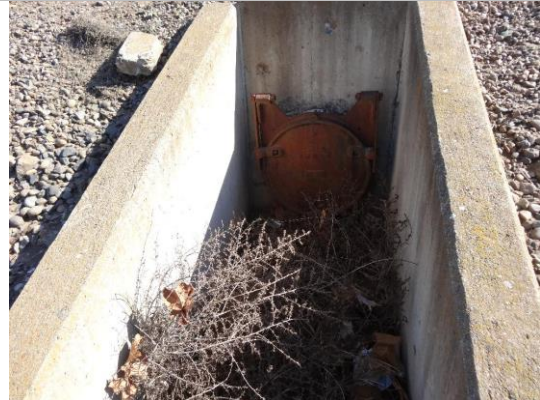
Photo 1 of 3 : UCIP_SP_2018_30763_56662.jpg

WS view: U type concrete headwall, pipe, and flapgate on levee slope.
Vegetation debris blocking outlet.

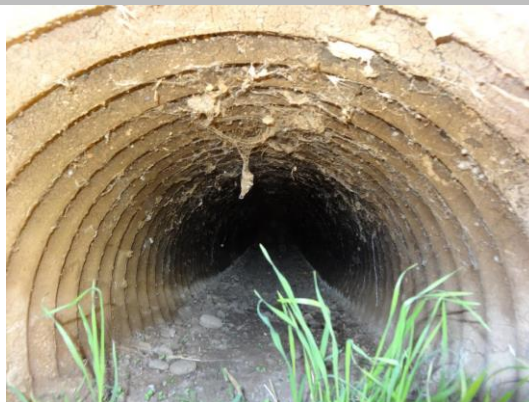
Photo 3 of 3 : UCIP_SP_2018_30763_56660.jpg

LS view: inside view of CMP on levee slope. Needs cleaning and clearing.

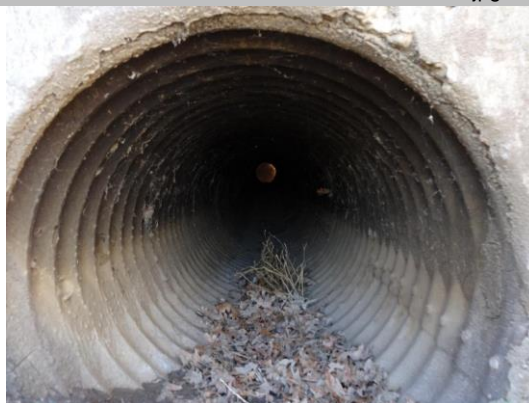
Photo 3 of 3 : UCIP_SP_2018_30783_56680.jpg

LS view: inside view of CMP on levee slope. Needs cleaning and clearing.

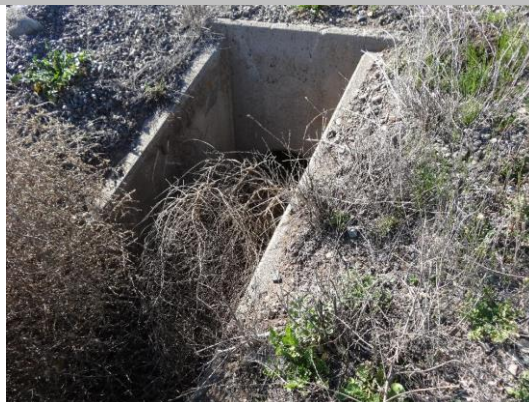
Photo 2 of 3 : UCIP_SP_2018_30803_56684.jpg

LS view: U type concrete headwall and CMP on levee slope. Vegetation debris and soil blocking inlet.

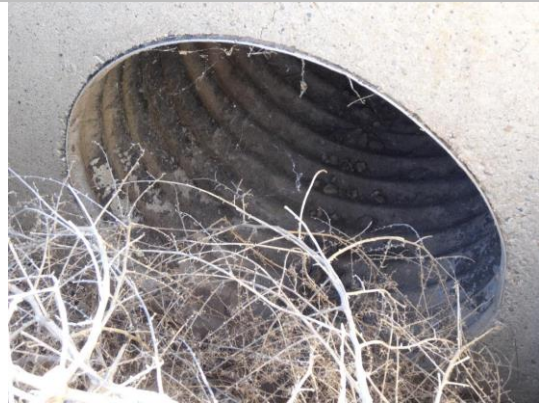
Photo 3 of 3 : UCIP_SP_2018_30803_56683.jpg

LS view: inside view of CMP on levee slope. Needs cleaning and clearing.

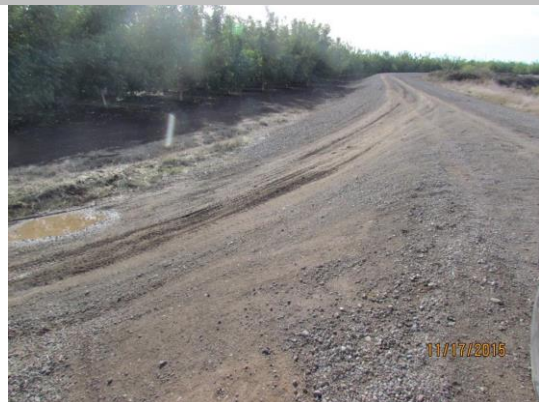
Photo 1 of 1 : SP_2018_NA0003_65_10_20180305_00007.jpg

View of the vehicle erosion along the landside slope.

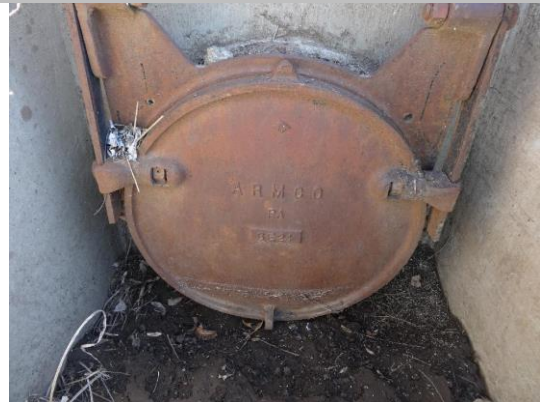
Photo 1 of 3 : UCIP_SP_2018_31028_56913.jpg

WS view: U type concrete headwall, pipe, and flapgate on levee slope.
Soil/mud on outlet box.

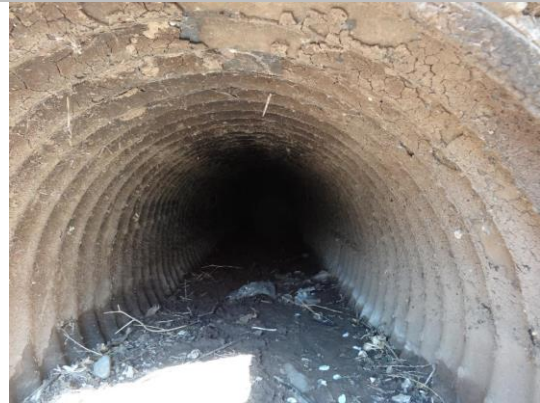
Photo 3 of 3 : UCIP_SP_2018_31031_56915.jpg

LS view: inside view of CMP on levee slope. Needs cleaning and clearing.

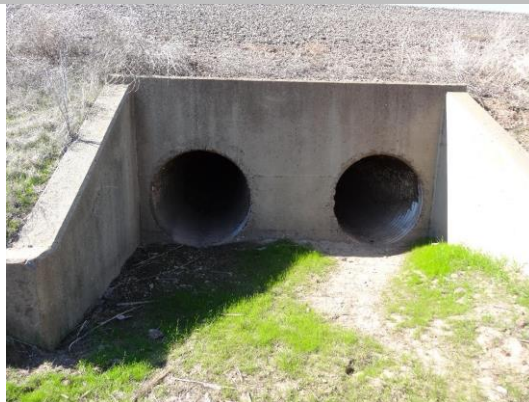
Photo 3 of 3 : UCIP_SP_2018_41376_56918.jpg

LS view: U type concrete headwall and CMPs on levee slope. Soil/mud on inlet box.

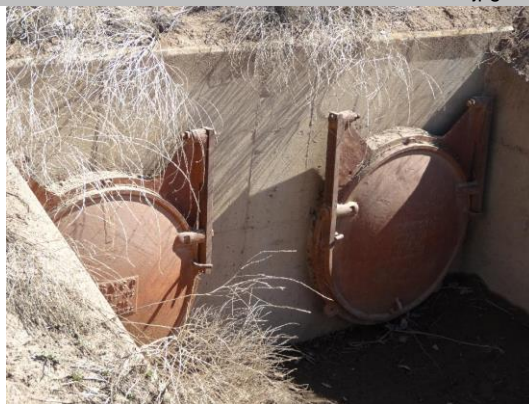
Photo 2 of 3 : UCIP_SP_2018_41377_56922.jpg

LS view: U type concrete headwall and CMPs on levee slope. Vegetation on inlet box.

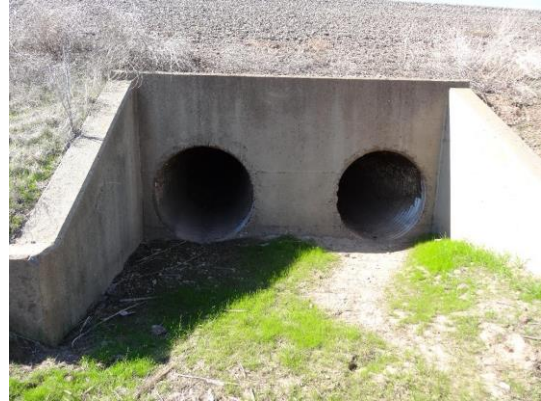
Photo 3 of 3 : UCIP_SP_2018_41377_56921.jpg

LS view: U type concrete headwall and CMPs on levee slope. Soil/mud on inlet box.

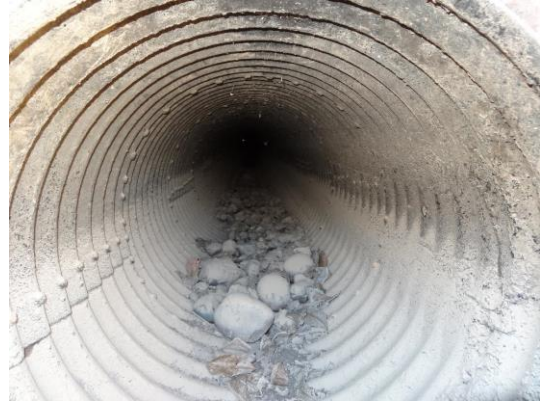
Photo 3 of 3 : UCIP_SP_2018_31085_56986.jpg

LS view: inside view of CMP on levee slope. Needs cleaning and clearing.

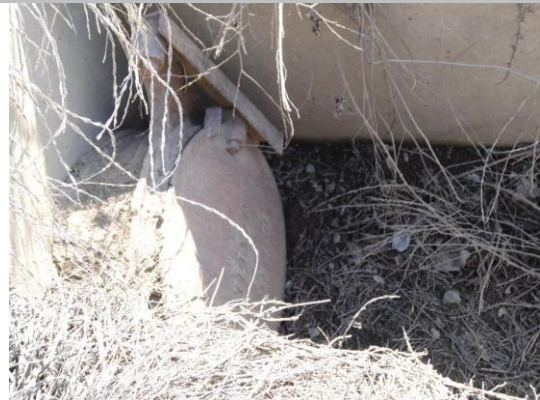
Photo 1 of 3 : UCIP_SP_2018_31103_57002.jpg

WS view: U type concrete headwall, pipe, and flapgate on levee slope. Soil/mud on outlet box. Vegetation debris blocking outlet box

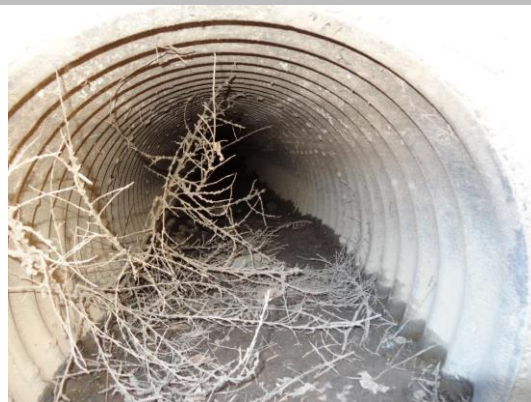
Photo 3 of 3 : UCIP_SP_2018_31103_57000.jpg

LS view: inside view of CMP on levee slope. Needs cleaning and clearing.

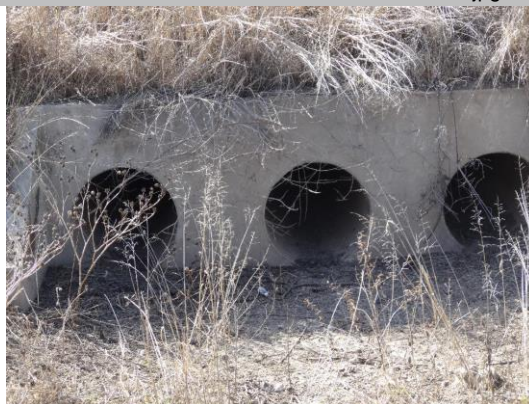
Photo 3 of 3 : UCIP_SP_2018_32085_58586.jpg

LS view: U type concrete headwall and CMPs on levee slope. Soil/mud on inlet box.

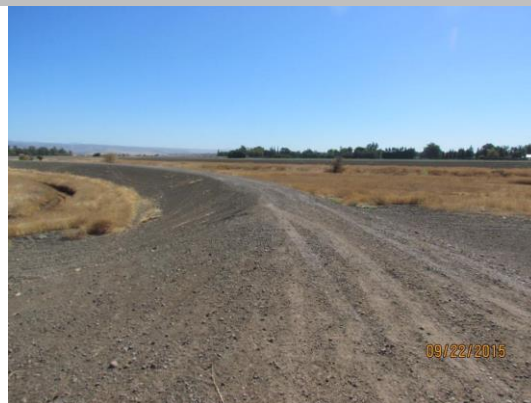
Photo 1 of 1 : SP_2018_NA0003_67_12_20180305_00002.jpg

View of the erosion on both slopes caused by motorcycle traffic.

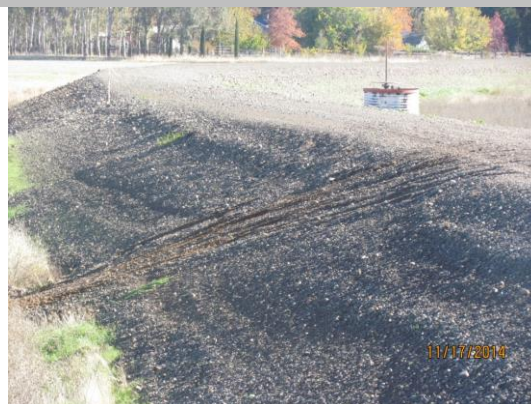
Photo 1 of 1 : SP_2018_NA0003_67_3_20180305_00001.jpg

View of the erosion caused by motorcycles on the land side slope.

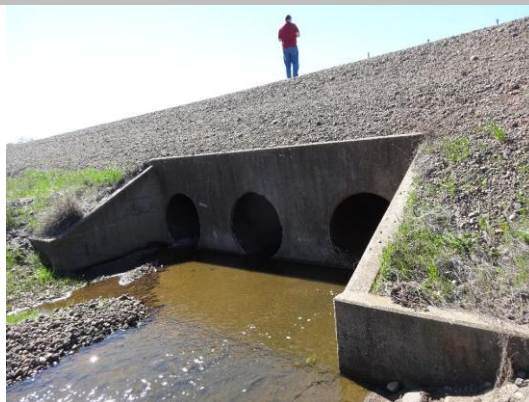
Photo 2 of 2 : UCIP_SP_2018_32104_58605.jpg

LS view: U type concrete headwall and three CMPs on levee slope. Soil/mud on inlet box.

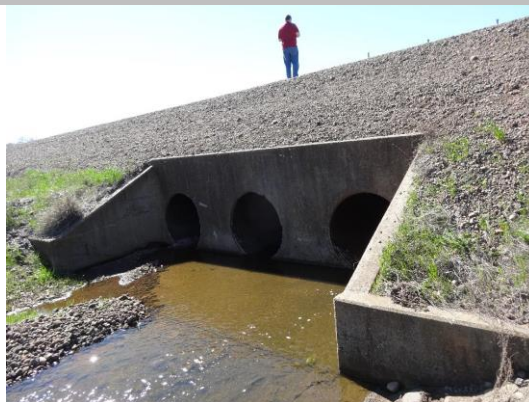
Photo 2 of 2 : UCIP_SP_2018_32105_58607.jpg

LS view: U type concrete headwall and three CMPs on levee slope. Soil/mud on inlet box.

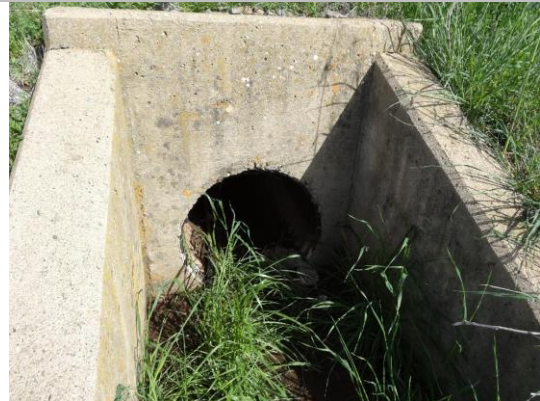
Photo 3 of 3 : UCIP_SP_2018_32124_58627.jpg

LS view: inside view of CMP on levee slope. Needs cleaning and clearing.

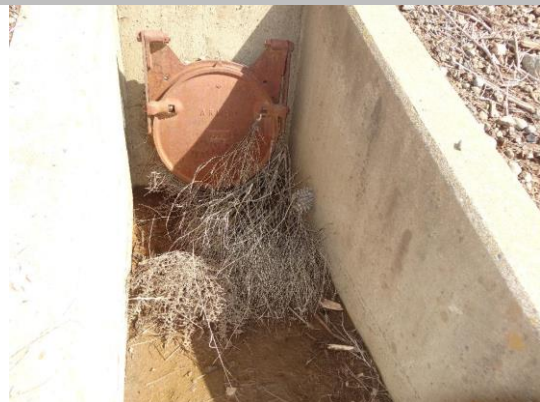
Photo 1 of 3 : UCIP_SP_2018_31901_58194.jpg

WS view: U type concrete headwall, flapgate, and CMP on levee slope. Needs cleaning and clearing.

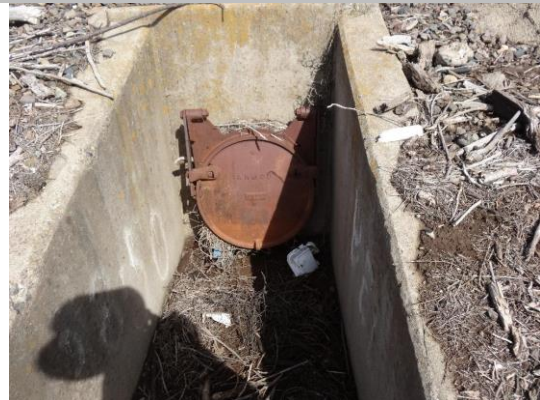
Photo 1 of 3 : UCIP_SP_2018_31864_58069.jpg

WS view: U type concrete headwall, pipe, and flapgate on levee slope. Soil/mud on outlet box. Vegetation debris blocking outlet box.

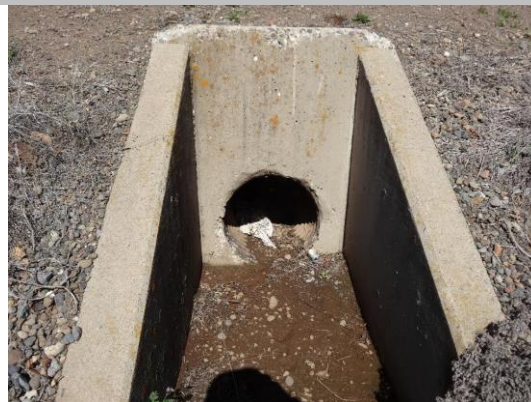
Photo 3 of 3 : UCIP_SP_2018_32026_58518.jpg

LS view: U type concrete headwall and CMP on levee slope. Mud and pebbles on inlet box.

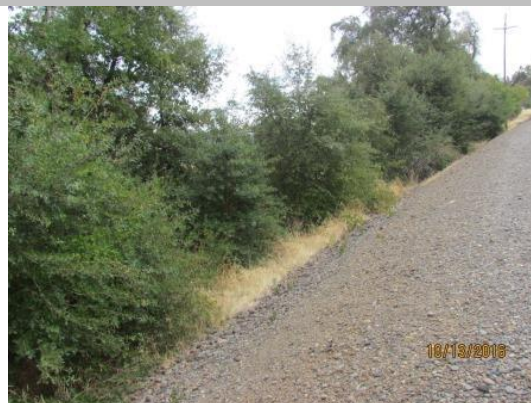
Photo 1 of 1 : SP_2018_NA0003_68_21_20180305_00007.jpg

View of the overgrown trees along the landside toe.

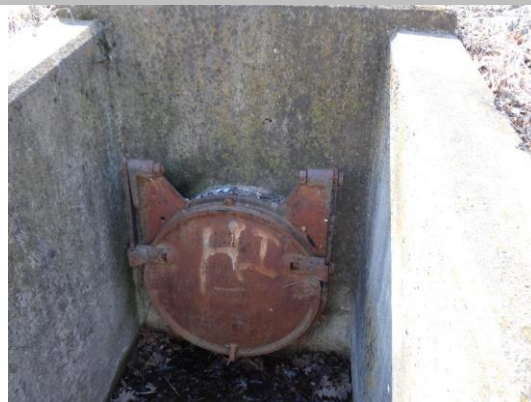
Photo 1 of 2 : UCIP_SP_2018_32143_58641.jpg

WS view: U type concrete headwall and CMP on levee slope. Soil/mud on outlet box. Needs cleaning and clearing.

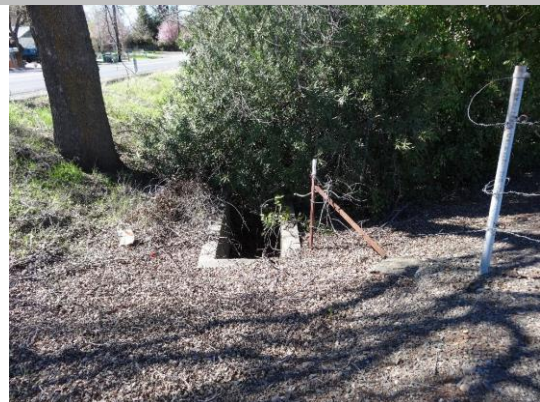
Photo 1 of 3 : UCIP_SP_2018_32144_58644.jpg

LS view: U type concrete headwall of CMP culvert on levee slope. Vegetation debris and mud on inlet box.

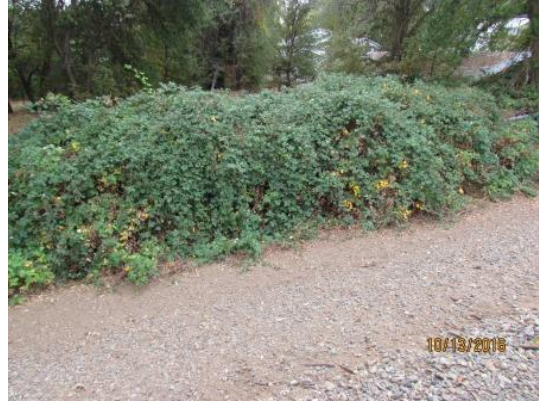
Photo 1 of 1 : SP_2018_NA0003_68_23_20180305_00009.jpg

View of the blackberries blocking visibility and access.

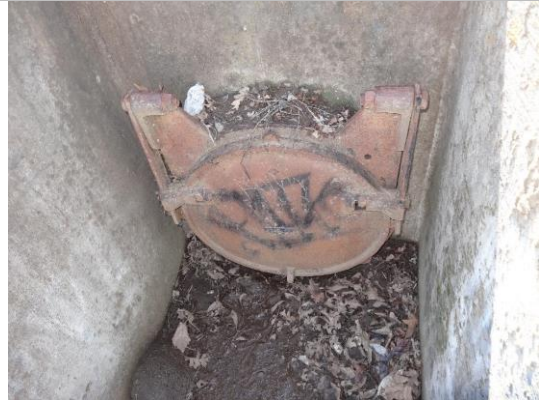
Photo 1 of 3 : UCIP_SP_2018_31963_58384.jpg

WS view: U type concrete headwall and CMP on levee slope. Vegetation debris and mud on outlet box. Needs cleaning and clearing.

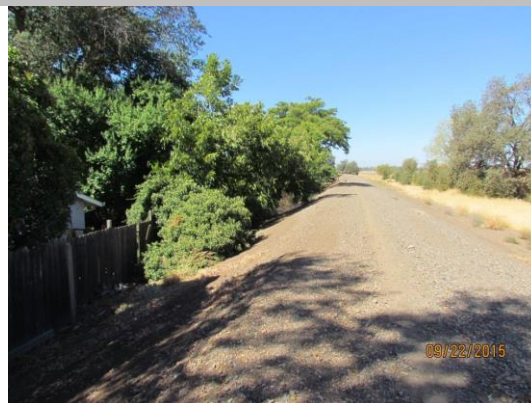
Photo 1 of 1 : SP_2018_NA0003_68_17_20180305_00004.jpg

View of the trees overhanging the levee slope.

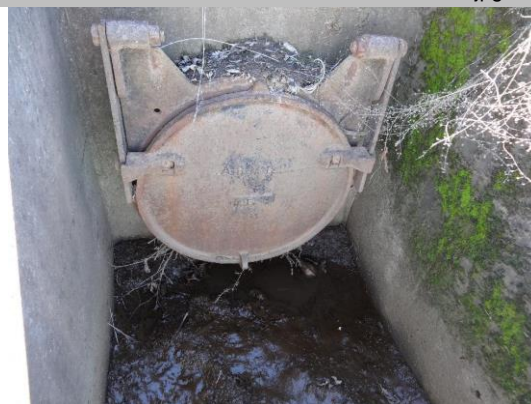
Photo 1 of 2 : UCIP_SP_2018_31964_58389.jpg

WS view: U type concrete headwall and CMP on levee slope. Vegetation debris and mud in outlet box. Needs cleaning and clearing.

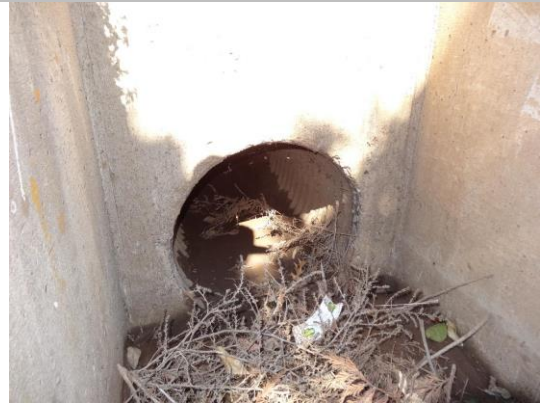
Photo 2 of 2 : UCIP_SP_2018_31964_58388.jpg

LS view: U type concrete headwall and CMP on levee slope. Vegetation debris and mud in inlet box.

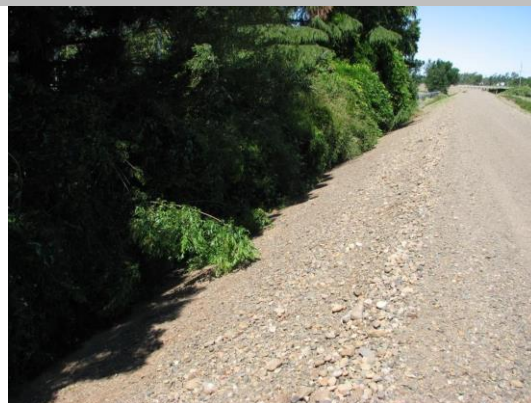
Photo 1 of 1 : SP_2018_NA0003_68_18_20180305_00005.jpg

View of the vegetation on fence at landside toe.

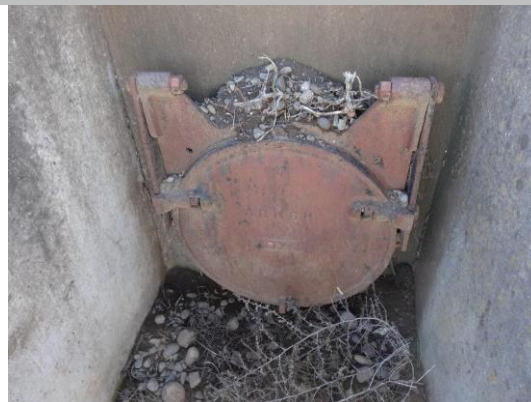
Photo 1 of 3 : UCIP_SP_2018_31965_58395.jpg

WS view: U type concrete headwall and CMP on levee slope. Vegetation debris and mud in outlet box. Needs cleaning and clearing.

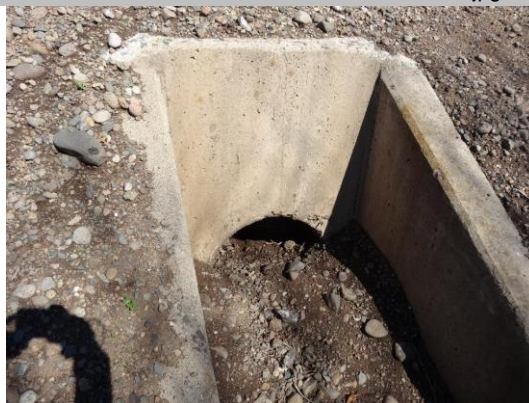
Photo 3 of 3 : UCIP_SP_2018_31966_58399.jpg

LS view: U type concrete headwall and CMP on levee slope. Vegetation debris and mud in pipe and inlet box.

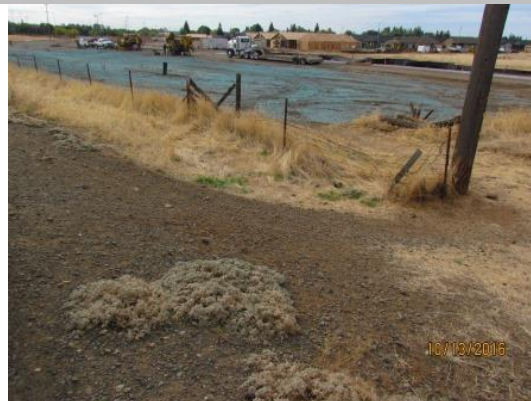
Photo 1 of 1 : SP_2018_NA0003_69_13_20180305_00011.jpg

View of the damaged slope by foot traffic.
